SAMPLING PLAN

**33777 Valley Center Road
in
Valley Center, California**

DATE: March 25, 2008

PROJECT NUMBER: 08-0311

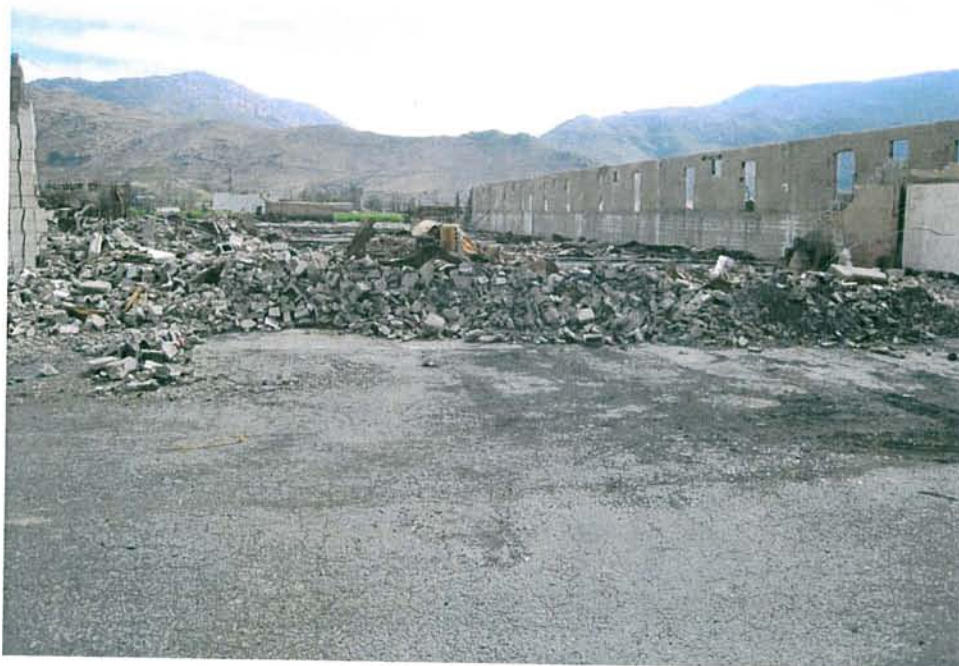
Subsequent to the October 2007 fire, the subject site appeared unchanged except for vast fire damage. The center area, where building had been located, comprised piles of concrete and metal rubble and scrap. Some of this was sorted and arranged in organized piles; other areas appeared not to have been sorted.

Overview of center of subject site, (previous location of onsite buildings).

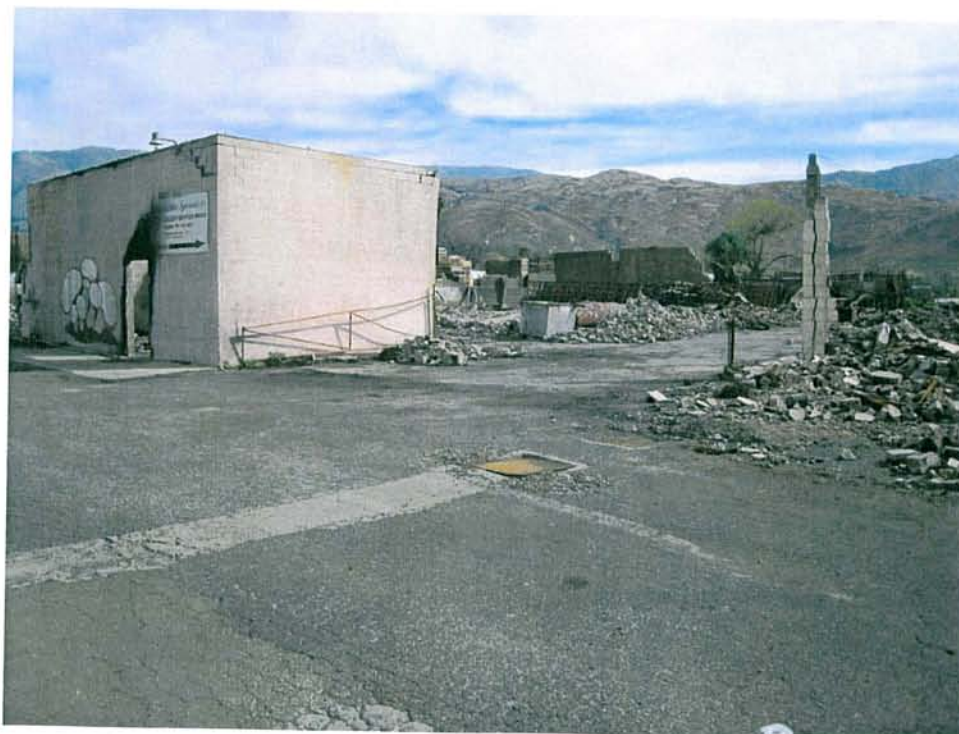
Another view of remaining structural elements near entrance to subject site, including covers reported as for a septic system.

A local contractor with experience in septic system forensics will be retained to map out the percolation systems including septic tanks, "tight" lines, and percolation lines. These will be flagged in the field, and rough surveyed so that they can be drawn onto a site plan.

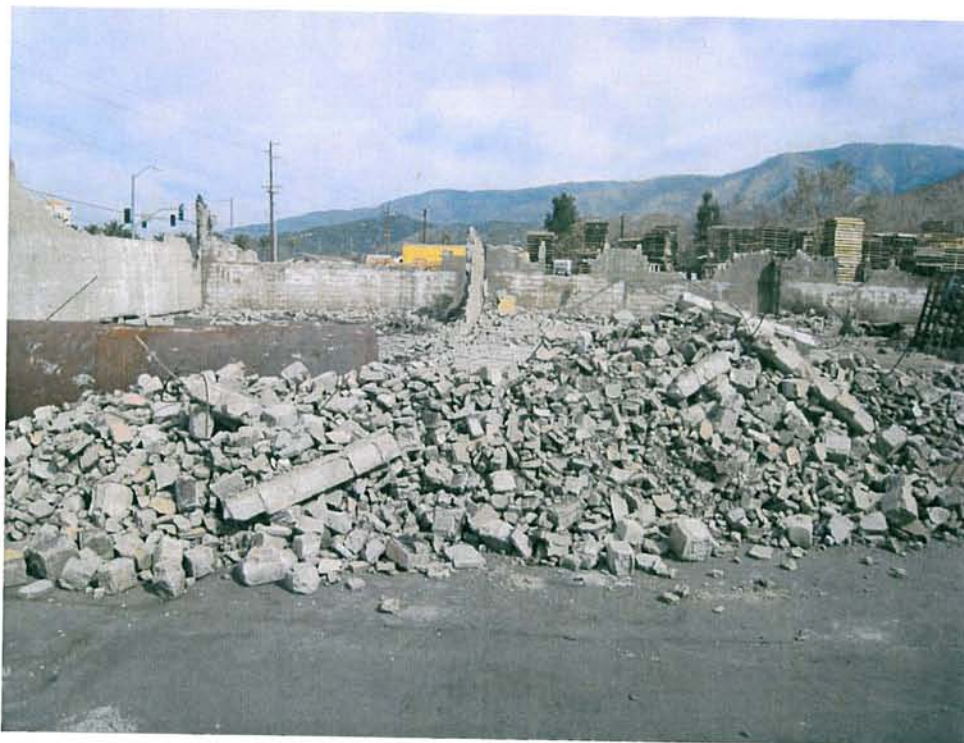
Piles of sorted rubble near center of subject site.

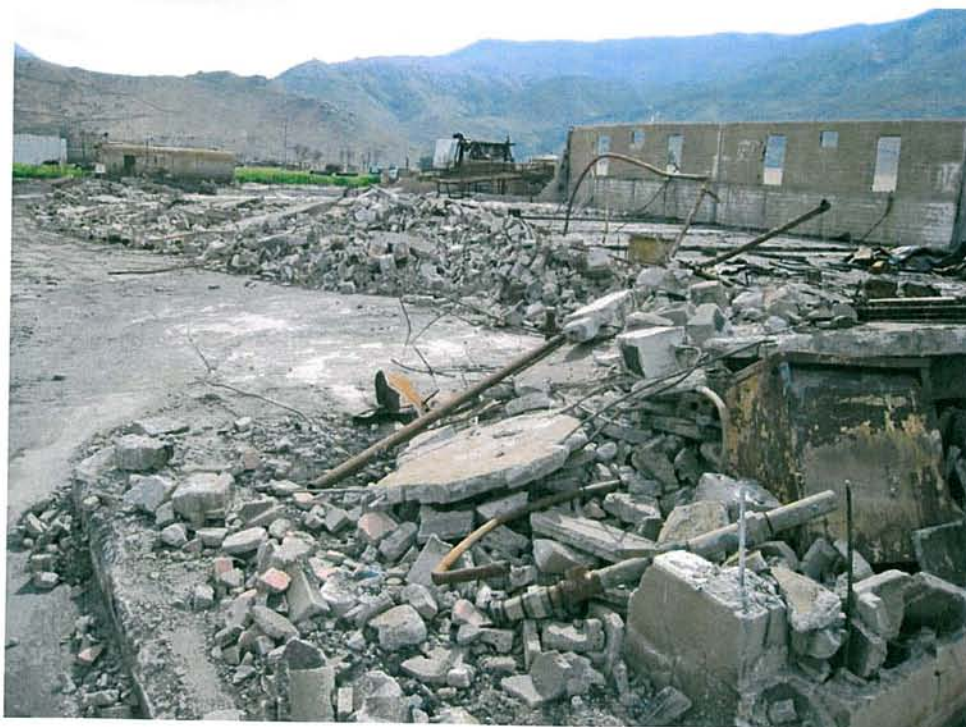
Unsorted materials present onsite.

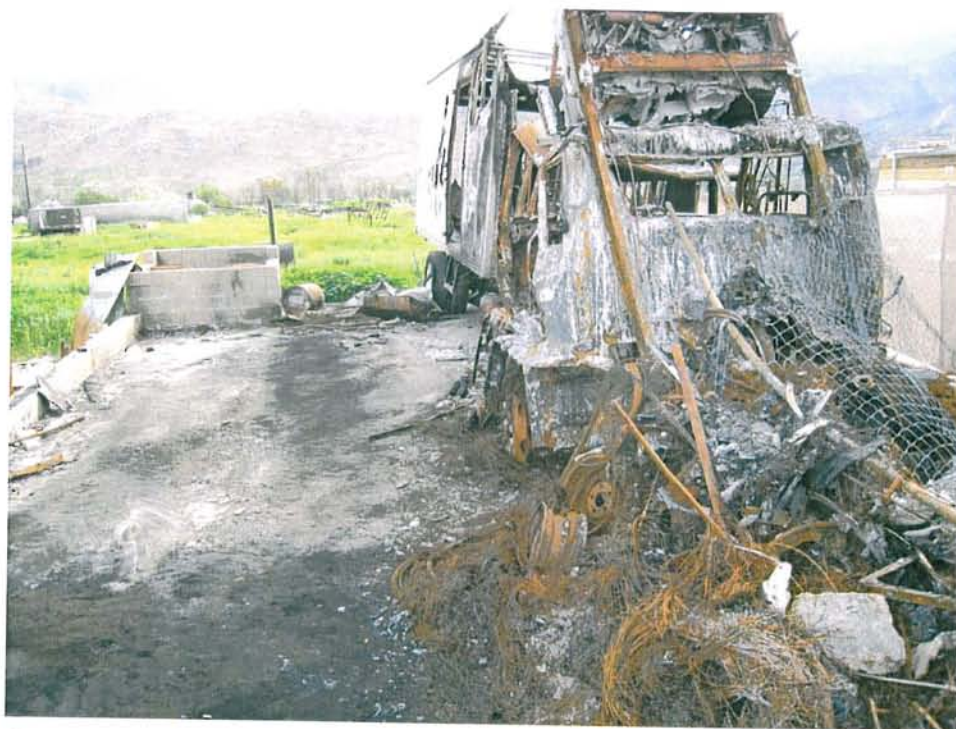
Soil in the area around the secondary containment area used for waste oil is suspected of having impact from waste oil, i.e., motor or hydraulic oils.

Northeast corner of paved area previously used by tow yard, including burnt truck and concrete block secondary waste oil enclosure.

- 1- Soil from the unpaved area alongside a secondary containment structure for waste oil (located along the east side of the subject site, near the northeast corner of the lot previously used by the towing company). Two sample locations will be selected for shallow (1-to-2-foot deep) samples here. Each will be from a random part of a selected grid element.

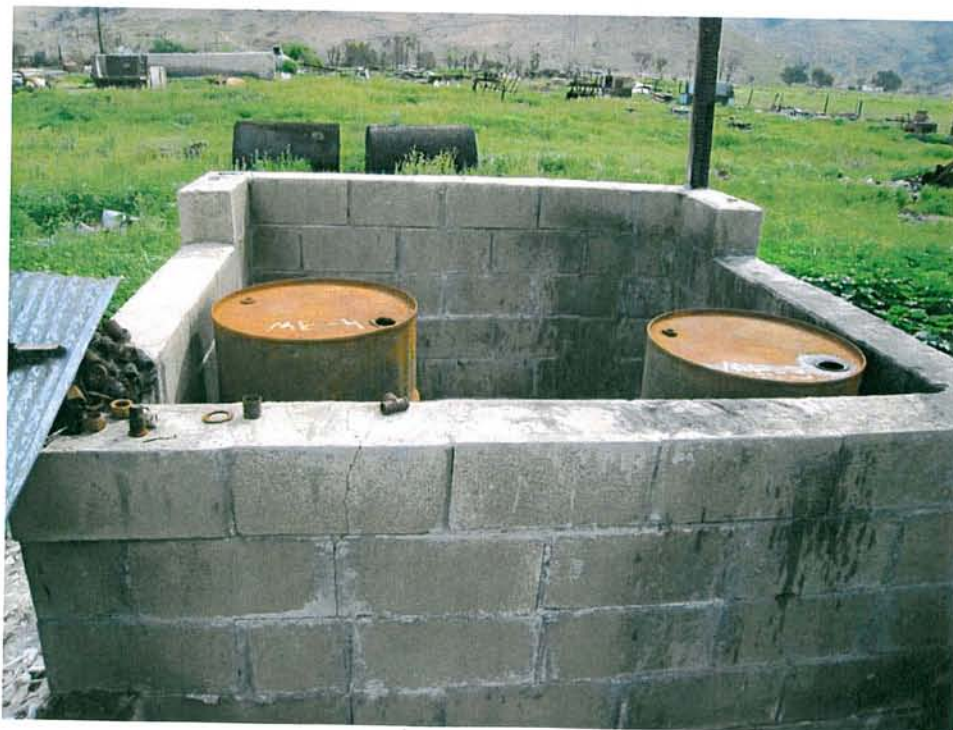
The southeast corner of the subject site, which had been the location of the towing yard, was still paved, and a number of cars were observed here. Several cars had been completely destroyed by the fires and materials from these vehicles were noted on the pavement. Condition of the pavement appeared relatively intact; no very large cracks or areas where penetrations of automotive contaminants were likely to have seeped through asphalt materials were noted. At the northeast corner of this paved area was the area used as a secondary containment for drums of waste oil. This area had also been damaged by fire, and it appeared that all oily products here had been burnt away. Small, residual amounts of waste oil mixed with water, etc. were observed in drums here.

Drums concrete block secondary containment, (some residual waste oil/water-sludge remaining in drums).

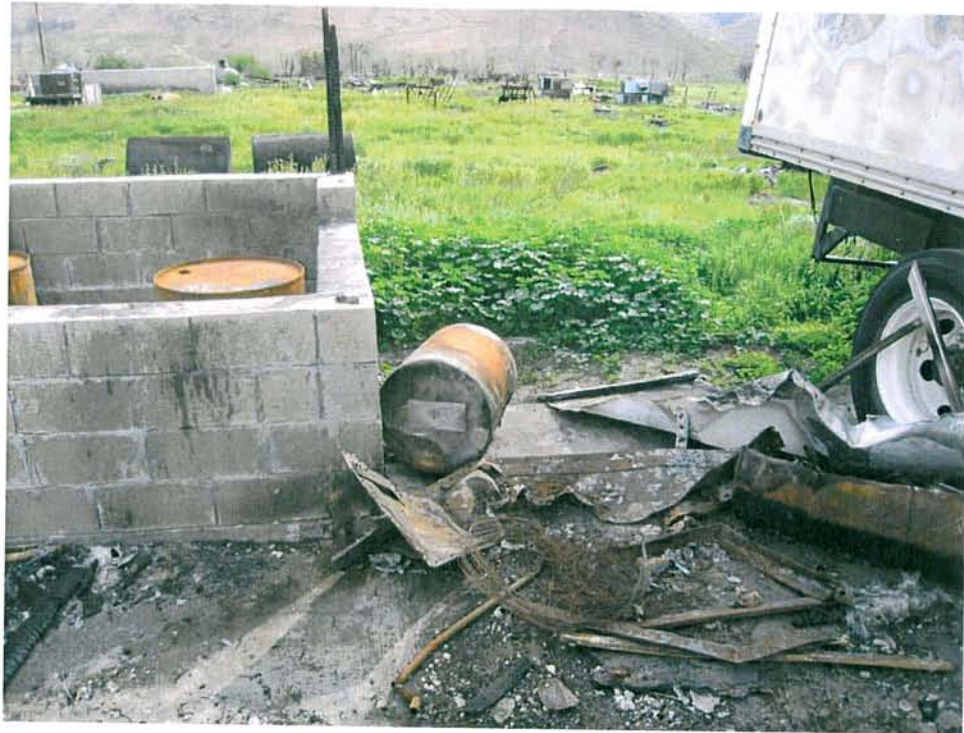
Paved and unpaved surfaces near fire-damaged secondary enclosure.

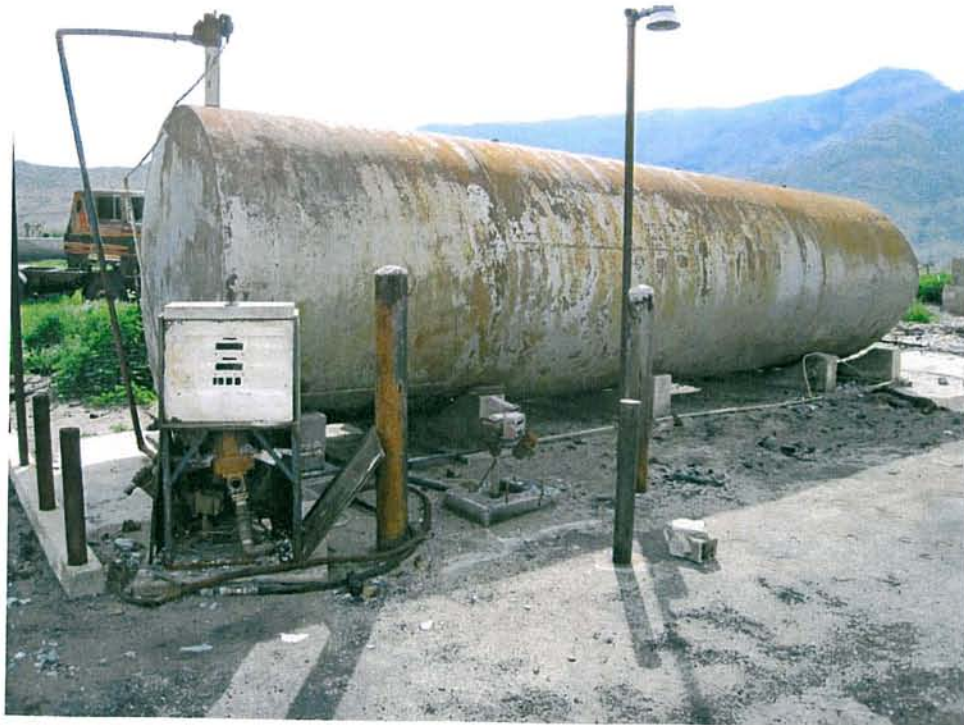
The aboveground diesel fuel storage tank along the east edge of the subject site was severely damaged. This had exploded in the fire and no fuel remained. An explosion caused by the fire appeared to have blown off the south end-plate of the tank (a horizontal cylinder) and to have moved the entire tank ca. 1.5-feet north of its original location in the concrete saddle. Pavement was noted beneath the associated dispenser; however, areas beneath the tank and within a few feet were unpaved.

Soil in the area around the burst diesel fuel tank is suspected of having impact from diesel fuel.

Aboveground diesel tank and dispenser, (far end burst in 2007 fire).

- 2- Soil from unpaved areas beneath and alongside the aboveground storage tank (used for diesel fuel), located near the center of the east side of the subject site. Four sample locations will be selected for shallow (1-to-2-foot deep) samples here. Each will be from a random part of a selected grid element.

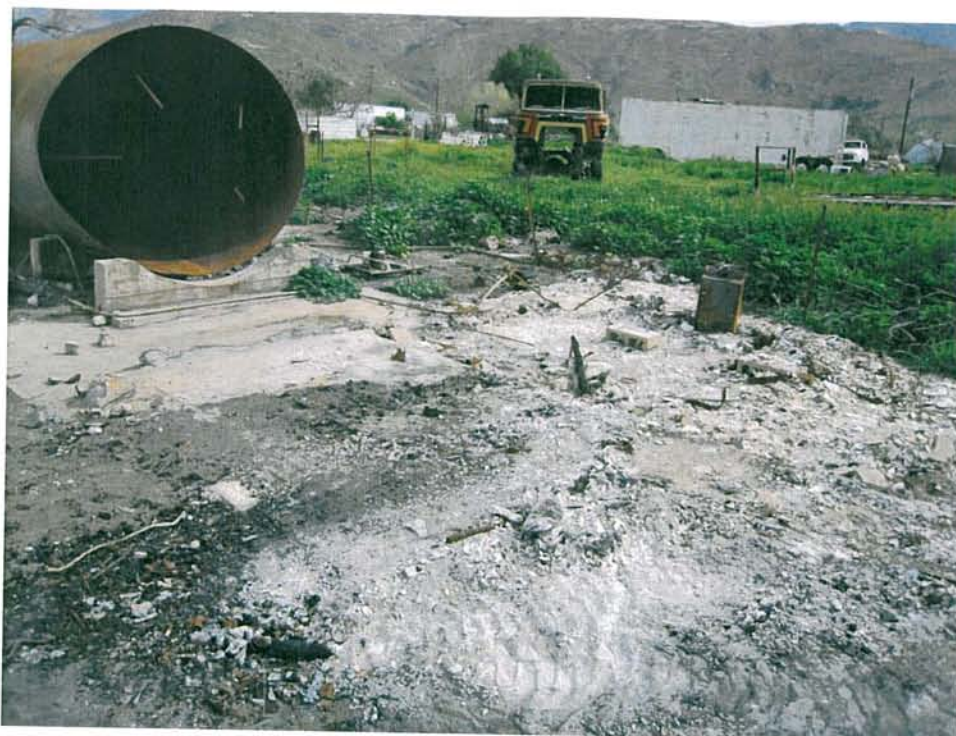
South end of diesel tank, burst off in fire, ash and debris in partially paved area.

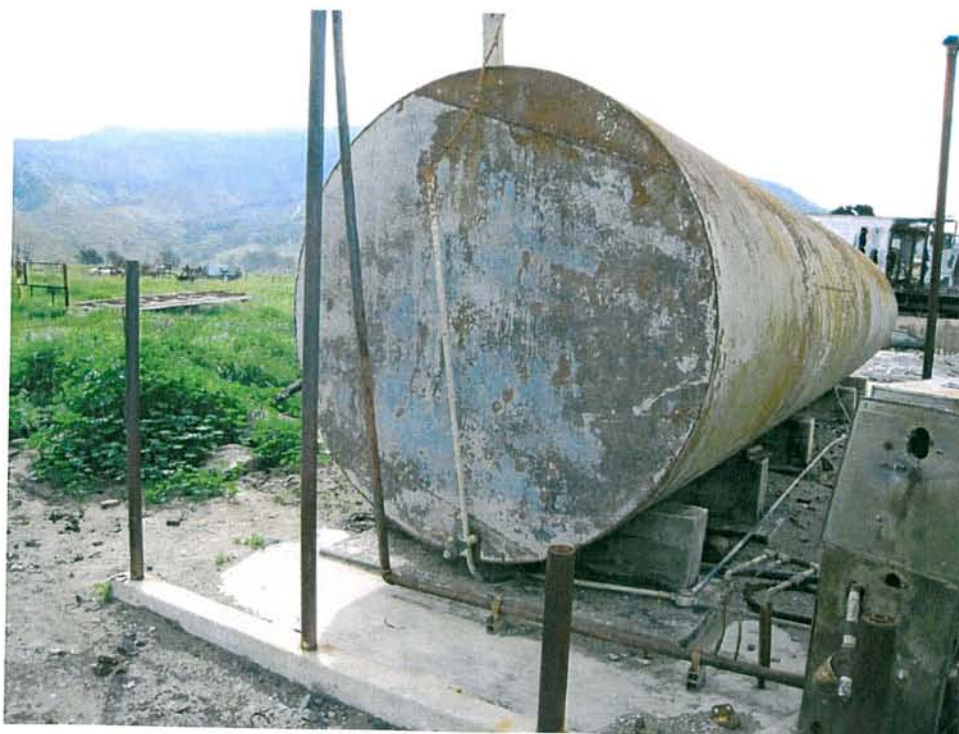
North end of diesel-fuel tank, associated piping which bent and displaced from bursting of far end (not shown).

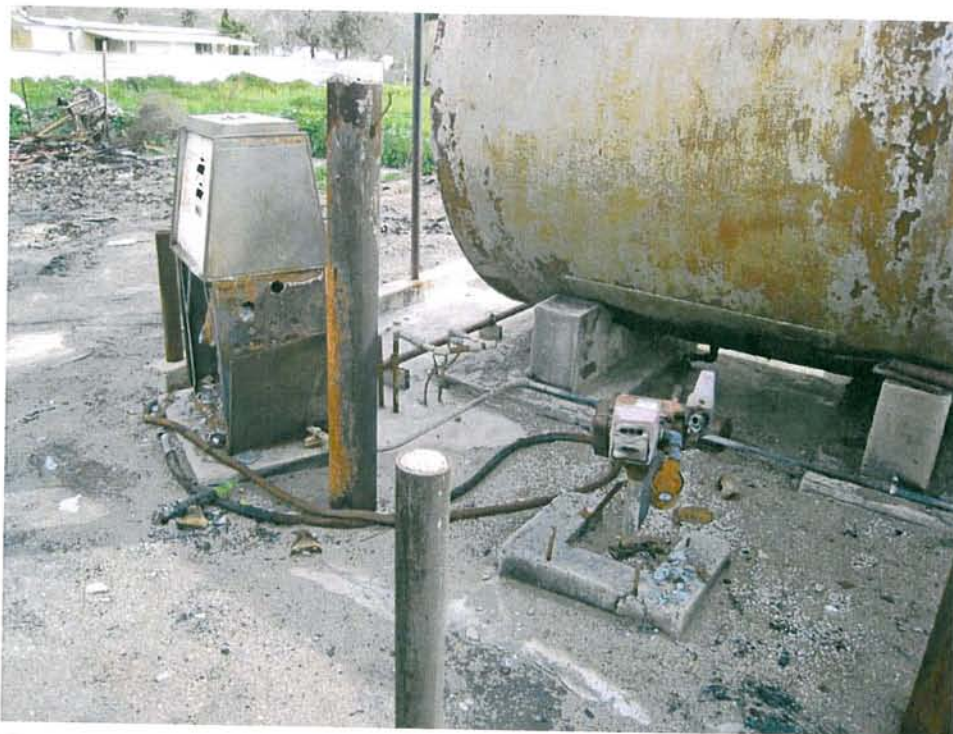
Dispenser and pump near north end of tank.

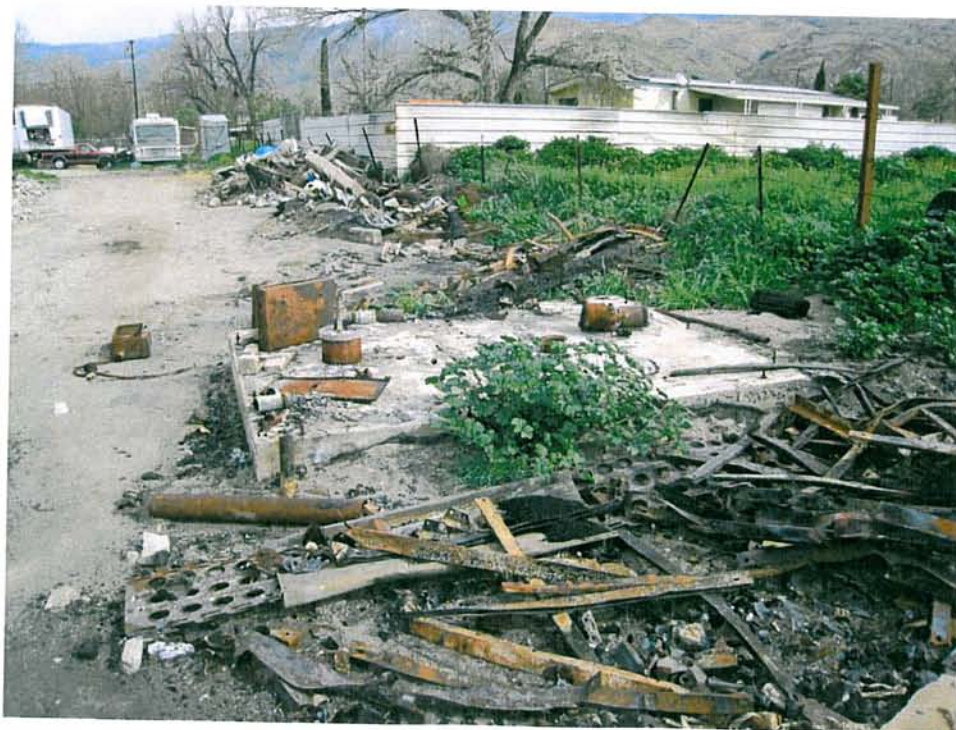
The wooden hut/shed structure that had previously surrounded the existing onsite water well had been destroyed; however the main elements of the well and its associated piping appeared undamaged.

Rubble and debris surrounding exterior remains of onsite groundwater well.

- 4- Water from the onsite water production well will be sampled.
- 5- Two composite samples will be taken of burn-ash. One will be taken from several locations on the west side of the subject site, and another will be similarly taken from the east side.

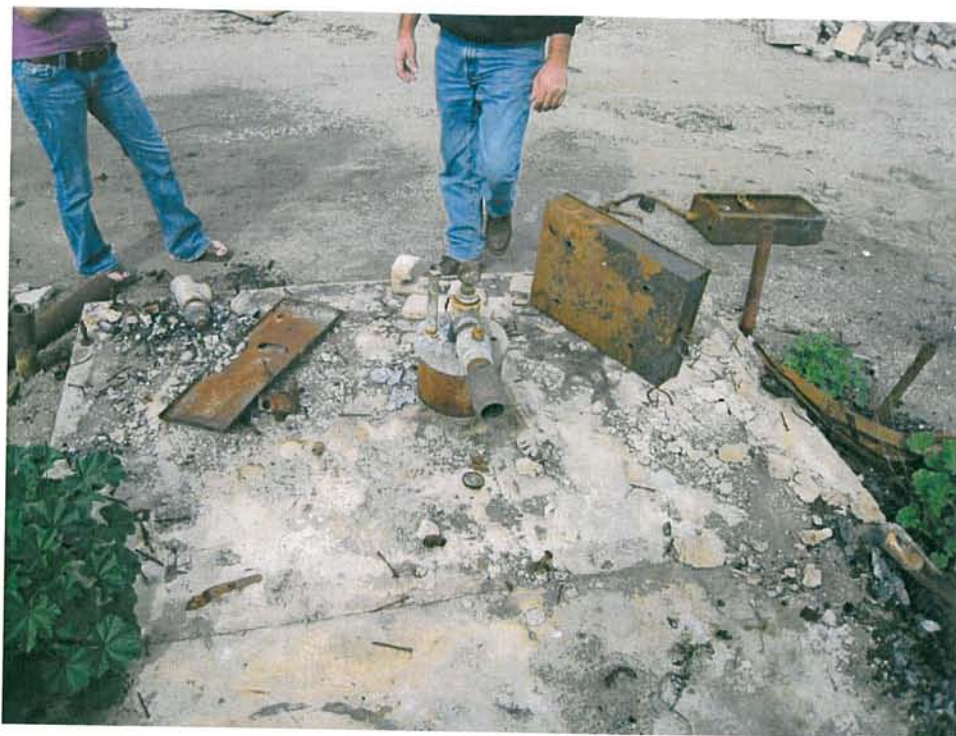
Exterior casing and fixtures of groundwater well.

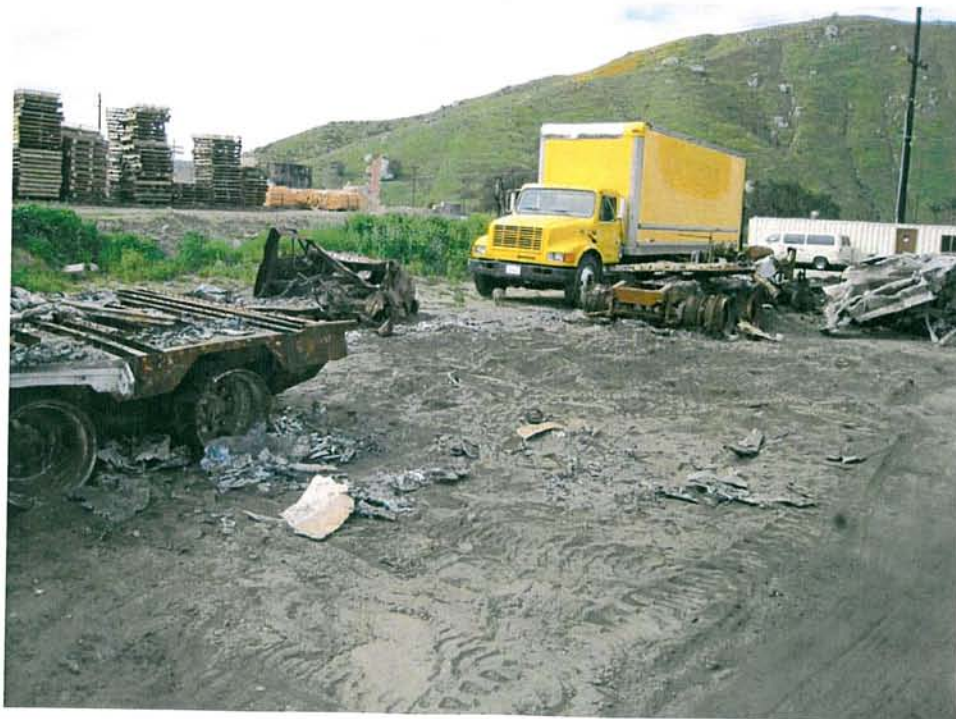
On the north side of the subject site, immediately north of the paved area that was the previous location of the onsite buildings, was an area where several large trucks had been parked. These were also seriously damaged in the fire, and the area had dark ash on the ground. The remains of the trucks had been removed, and the top layer of soil appeared to have been raked over. Small piles of ash and related remnants of the fire were observed in this general area and across the entire site.

Soil in the area of fire-damaged vehicles parked over an unpaved area is suspected of having impact by petroleum hydrocarbons in the diesel fuel and gasoline ranges and by heavier hydrocarbons, e.g., motor or hydraulic oils.

Area on north end of site, where vehicles burned over unpaved area.

- 3- Soil from the unpaved area immediately north of the paved center of the subject site and the previously existing buildings, where several vehicles were destroyed by fire and where ash and darkened soil was observed. Four locations will be selected for shallow (1-to-2-foot deep) samples here. Each will be from a random part of a selected grid element.

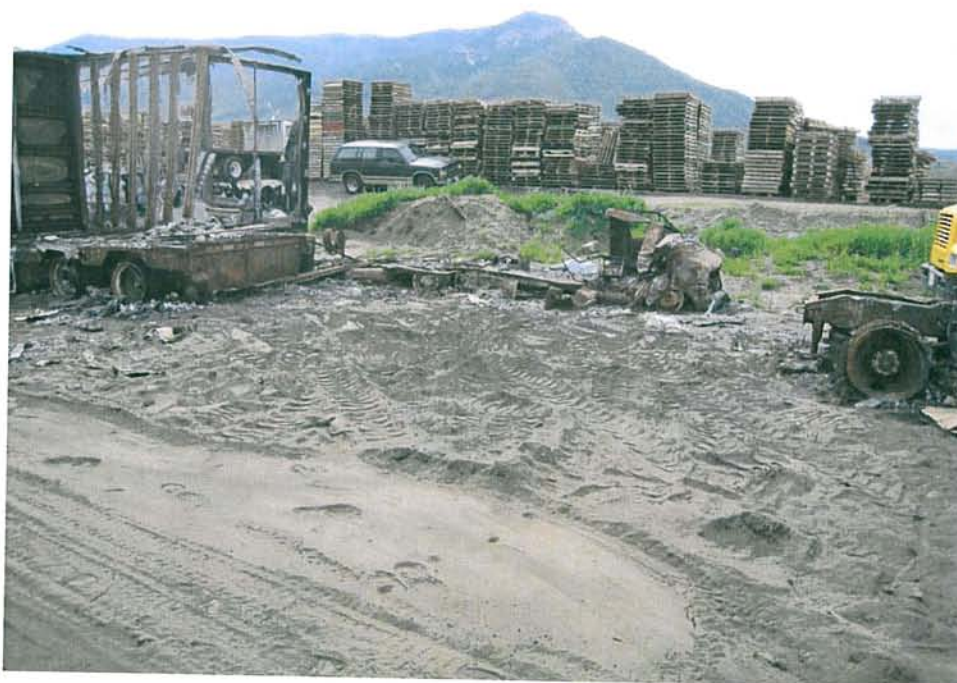
Darkened soil and ash where debris from unpaved area where vehicles burned.
